# The Influence of Hydrogen Peroxide Sterilisation on Plastic Surface

### Rika Yoshida, Hiroyoshi Kobayashi

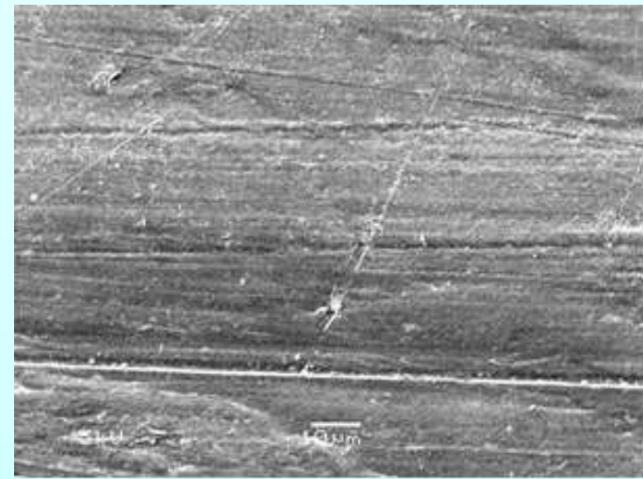
Figure 1-1. SEMF of PA6 panel-surface before sterilisation (×1000)

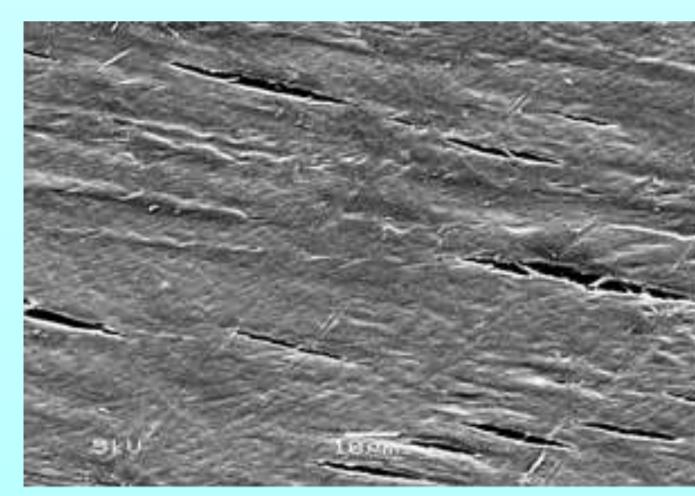
Figure 1-2. SEMF of PA6 panel-surface after once of sterilisation by LTHPGPS (×1000)

The results of the scanning electron microscopic finding (SEMF) are shown in Figures 1 to 4. On the surfaces of PA6 after the two types of sterilisations crack and crakle are occurred as shown Figure 1-2 to 1-4 after the sterilisations. On the surfaces of PP, many scattered seed-like changes as were observed as in Figure 2-2 and 2-3. On the surfaces of other plastic panels, no apparent changes were observed after the sterilisations.

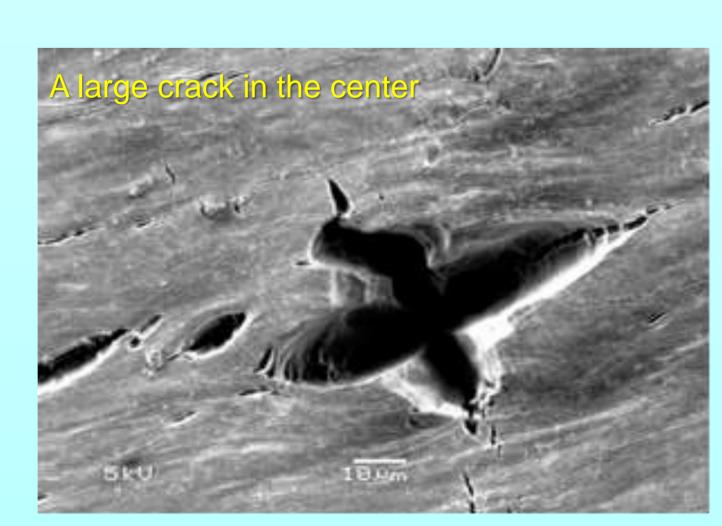
Figure 1-3. SEMF of PA6 panel-surface after five repeated procedures of sterilisation by LTHPGPS (×1000)

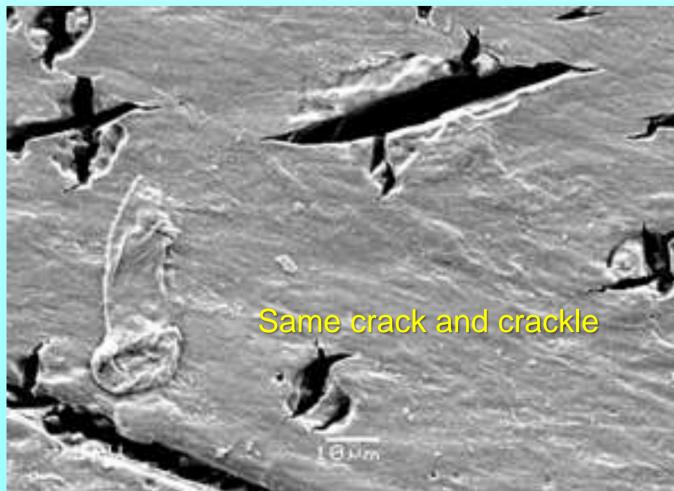
Figure 1-4. SEMF of PA6 panel-surface after once of sterilisation by LTHPVS (×1000)

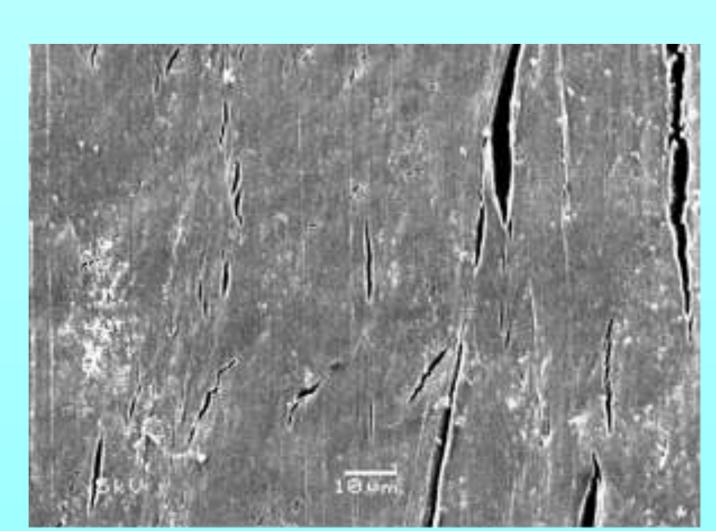
Figure 1-5. SEMF of PA6 panel-surface after five repeated procedures of sterilisation by LTHPVS (×1000)

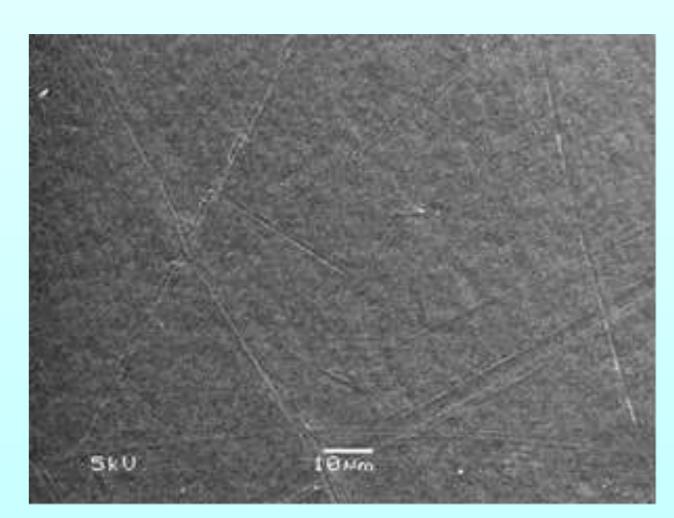
Figure 3-1. SEMF of PP panel-surface before sterilisation (×1000)

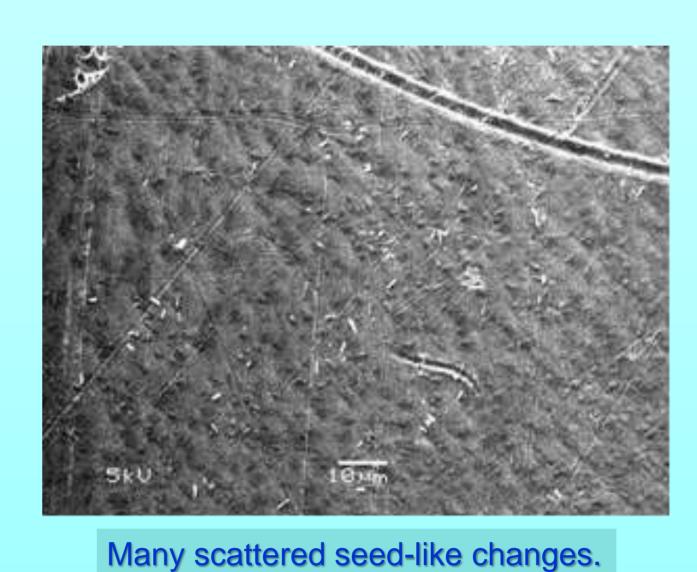
Figure 3-2. SEMF of PP panel-surface after five procedures of sterilisation by

LTHPGPS (×1000)

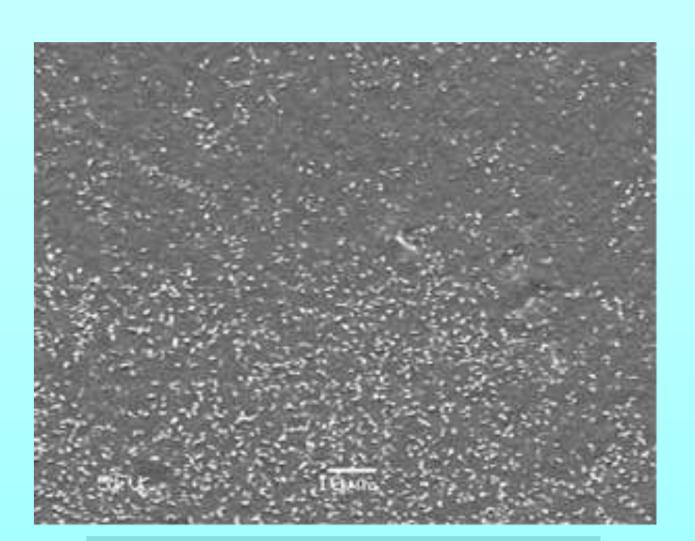
More scattered seed-like changes

Figure 3-3. SEMF of PP panel-surface after five procedures of sterilisation by LTHPVS (×1000)
