■ Express reports

Influence of Hydrogen Peroxide Sterilisation on Plastic Surface

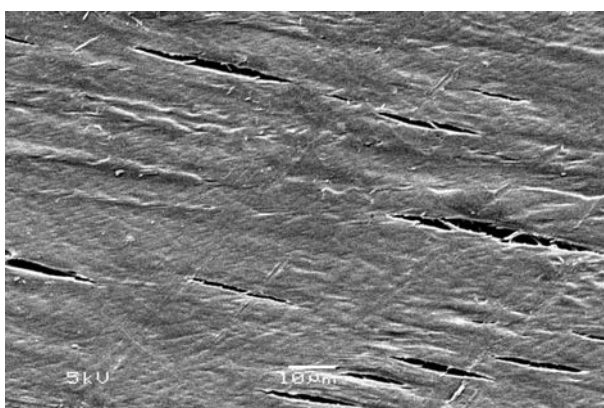
Figure 1-2. SEI of PA6 panel-surface PA6 after once of sterilisation by LHPGPS (×1000)

Crack and crackle on the surface.

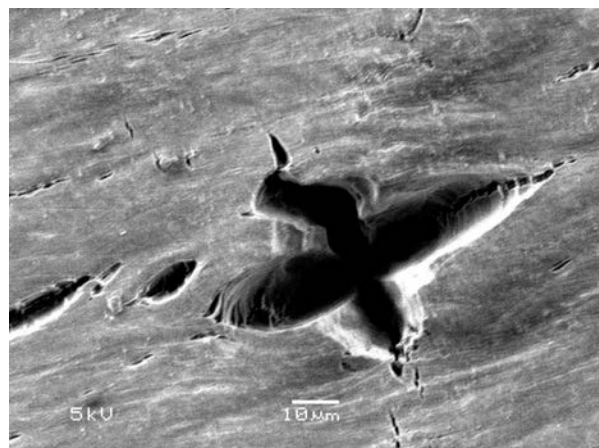
Figure 1-3. SEI of PA6 panel-surface PA6 after five repeated procedures of sterilisation by LHPGPS (×1000)

A large crack in the center.

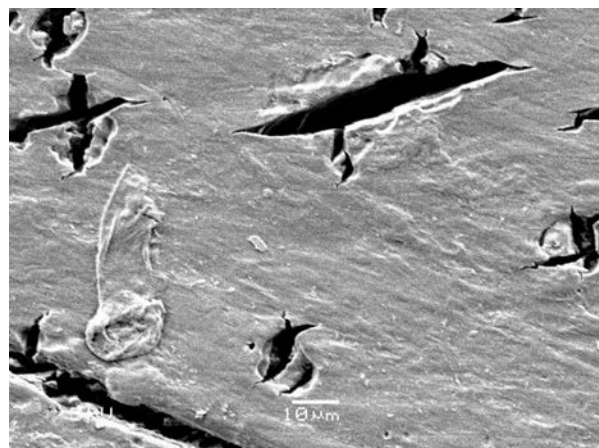
Figure1-4. SEI of PA6 panel-surface after once of sterilisation by LHPVS (×1000)

Same crack and crackle as after LHPGPS.

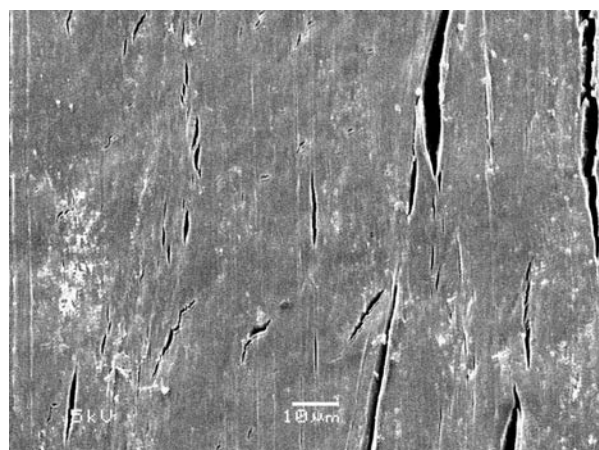
Figure1-5. SEI of PA6 panel-surface after five repeated procedures of sterilisation by LHPVS (×1000)

Same crack and crackle as after LHPGPS.

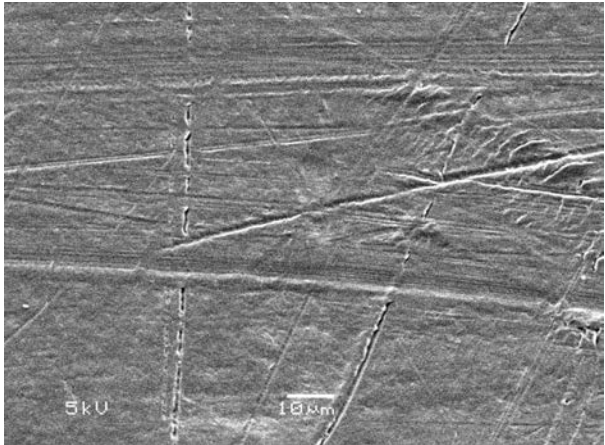
Figure2-4. SEI of PE panel-surface after oinces of sterilisation by LHPVS (×1000)

Uneven surface.

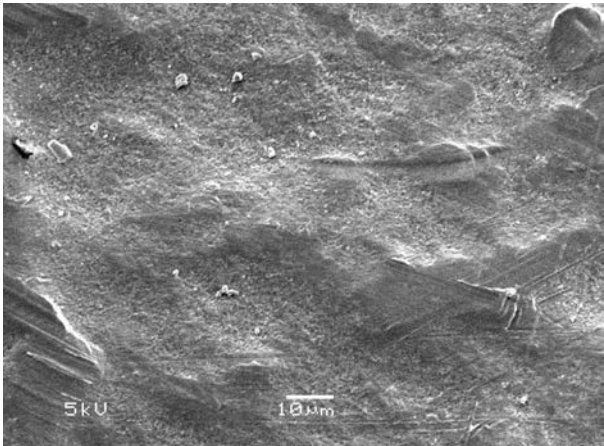
Figure2-2. SEI of PE panel-surface after once of sterilisation by LHPGPS (×1000)

Lumpy surface.

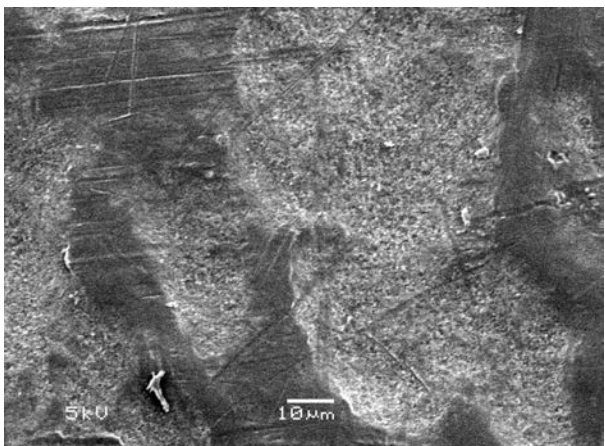
Figure2-5. SEI of PE panel-surface after five repeated procedures of sterilisation by LHPVS (×1000)

Bumpy surface.

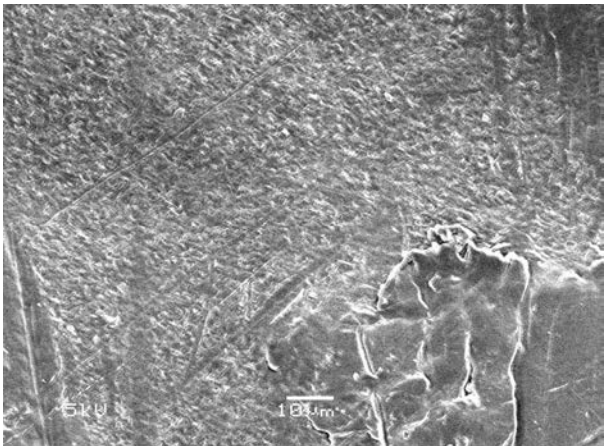
Figure2-3. SEI of PE panel-surface after five repeated procedures of sterilisation by LHPGPS (×1000)

Rugged surface.

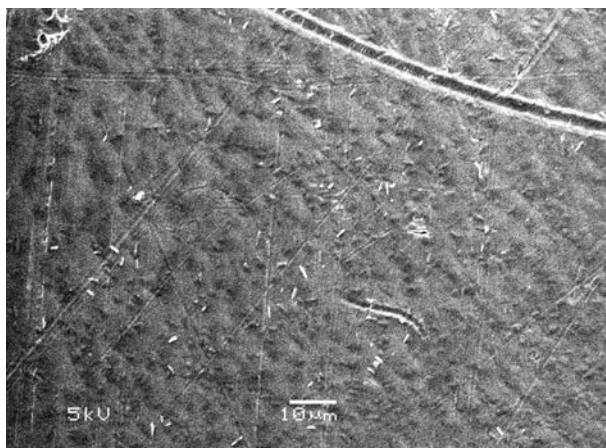
Figure3-2. SEI of PP panel-surface after five procedures of sterilisation by LHPGPS ($\times 1000$)

Many scattered seed-like changes.

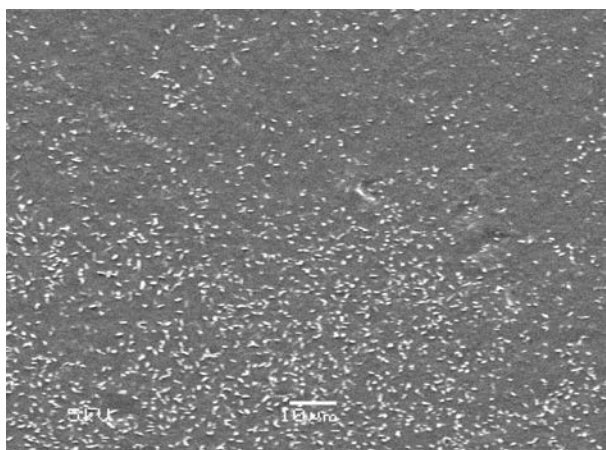
Figure3-3. SEI of PP panel-surface after five procedures of sterilisation by LHPVS ($\times 1000$)

More scattered seed-like changes than in Figure 3-2.

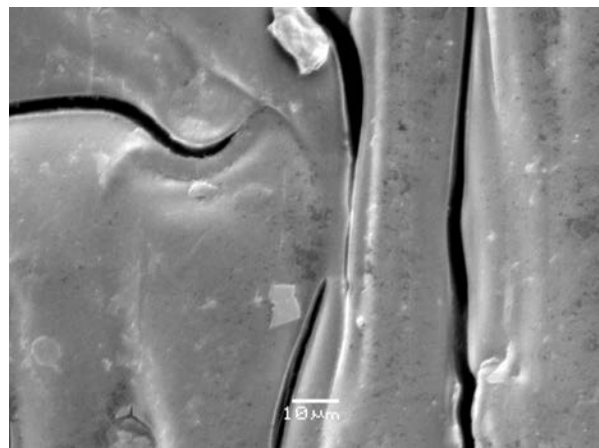
Figure4-2. SEI of Stapler (PA6) handle-surface after five procedures of sterilisation by LHPGPS ($\times 1000$)

In SEI of stapler handle, cracks are demonstrated on the surfaces after sterilisations as shown in Figure 4-2 and 4-3. .

Cracks are observed on the surface of stapler handle.

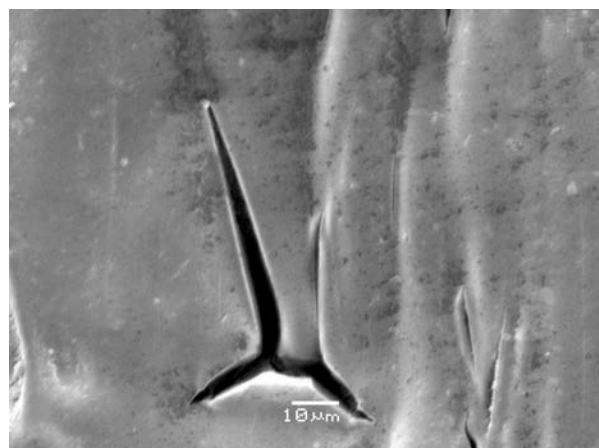
Figure4-3. SEI of Stapler (PA6) handle-surface after ten procedures of sterilisation by LHPGPS ($\times 1000$)

Cracks are observed also on the surface of stapler handle, but there is no difference between the handle surfaces sterilised five and ten times.
